# Vascular Flora on Croatian Historic Structures: Drivers of Biodeterioration and Conservation Implications

**Abstract:** Biodeterioration, the alteration of materials by living organisms, affects approximately two-thirds of the world's cultural heritage. When organisms colonize the surfaces, they induce physical and chemical changes that can lead to significant damage. Despite its relevance, this phenomenon remains understudied in Croatia. This study aims to assess the deteriogenic vascular flora colonizing Croatian historical structures, including castles, towers, and archaeological remains, in relation to several environmental and anthropogenic factors: distance from the sea (0–1, 1–10, 10–65, and 65–165 km), elevation (0–50, 50–150, 150–300, and 300–600 m a.s.l.), exposure (north, south, east, west), and the state of conservation of the site (absent, low, good, excellent). Vegetation cover and floristic diversity, assessed using the Shannon Index, were primarily influenced by elevation and conservation status. As expected, vegetation cover decreased significantly, by 67.75%, from sites classified as 'Absent' to those with 'Excellent' conservation status ( $p < 0.001$ ). To exp

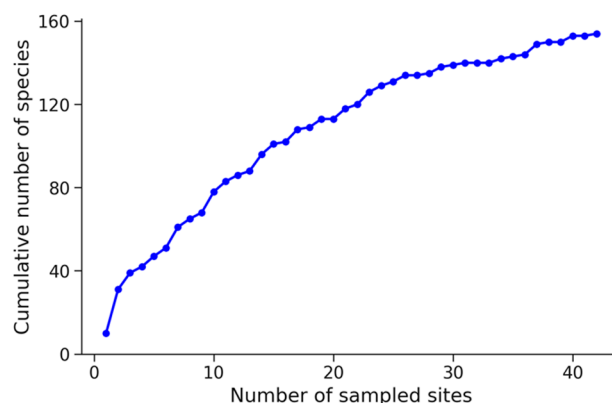
**Figure 1.** Species accumulation curve as a function of sampling effort. The curve shows the cumulative number of species observed as the number of sampling units increases.

A total of 154 taxa from 58 families were documented across the 40 study sites (Supplementary Materials, Table S1). Figure 1 shows the cumulative increase in species richness as the number of collected samples and surveyed sites increases.

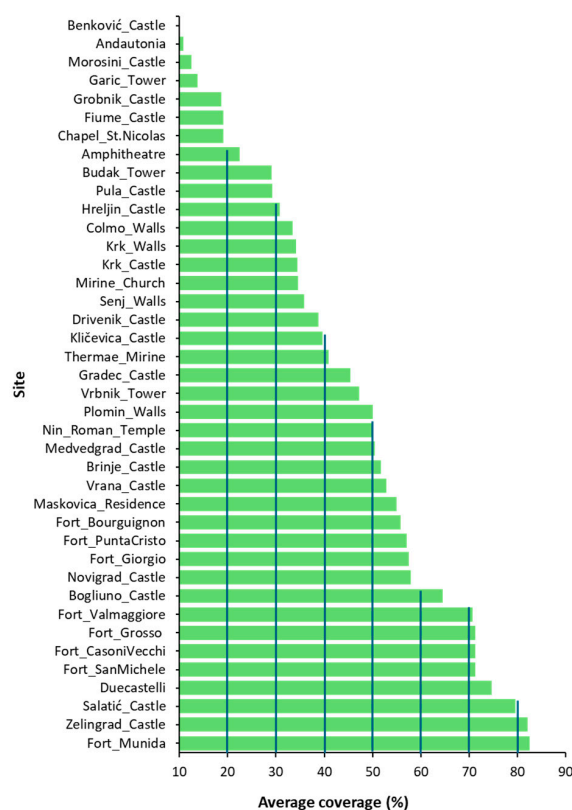
Figure 2. Average coverage across the 40 study sites.

Figure 2 presents the average species coverage across the study sites, with Fort Munida in Pula showing the highest species abundance (82.5%), followed by Zelingrad Castle in Kladešćica (82%) and Salatić Castle in Vrh (79.5%).

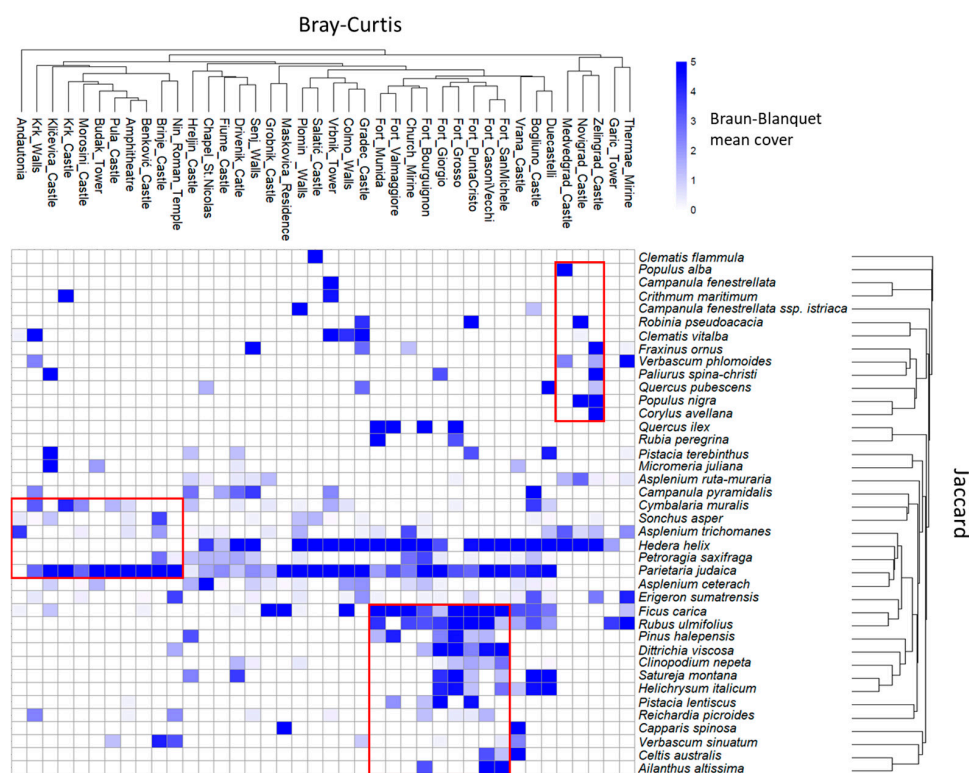
Figure 3. Heatmap with the relative abundance of the 40 most frequent taxa across study sites. Hierarchical clustering of sites is based on the Bray–Curtis dissimilarity, while species are ordered according to the Association Index. The red boxes indicate the three representative clusters.

The Bray–Curtis dendrogram (Figure 3) illustrates the clustering of study sites based on species composition, ordered according to the Jaccard Index of Association. The heatmap reveals several distinct clusters: (1) a cluster including Zelingrad, Novigrad, and Medvedgrad Castles; (2) a cluster encompassing the fortresses of Munida, Valmaggione, Fort Bourguignon, Giorgio, Grosso, Punta Cristo, Casoni Vecchi, San Michele, and the church of Mirine; (3) a cluster comprising Andautonia, the walls of Krk, the Amphitheatre of Pula, the Roman Temple of Nin, Kličevica, as well as the castles of Krk, Morosini, Pula, Benković, Brinje, and Budak tower.

While the analysis of average vegetation coverage offers a general overview of site conditions, the heatmap in Figure 3 provides a more detailed perspective by highlighting floristic patterns and site-species affinities. Specifically, the heatmap revealed three distinct clusters of sites, each characterized by a different composition of dominant species.

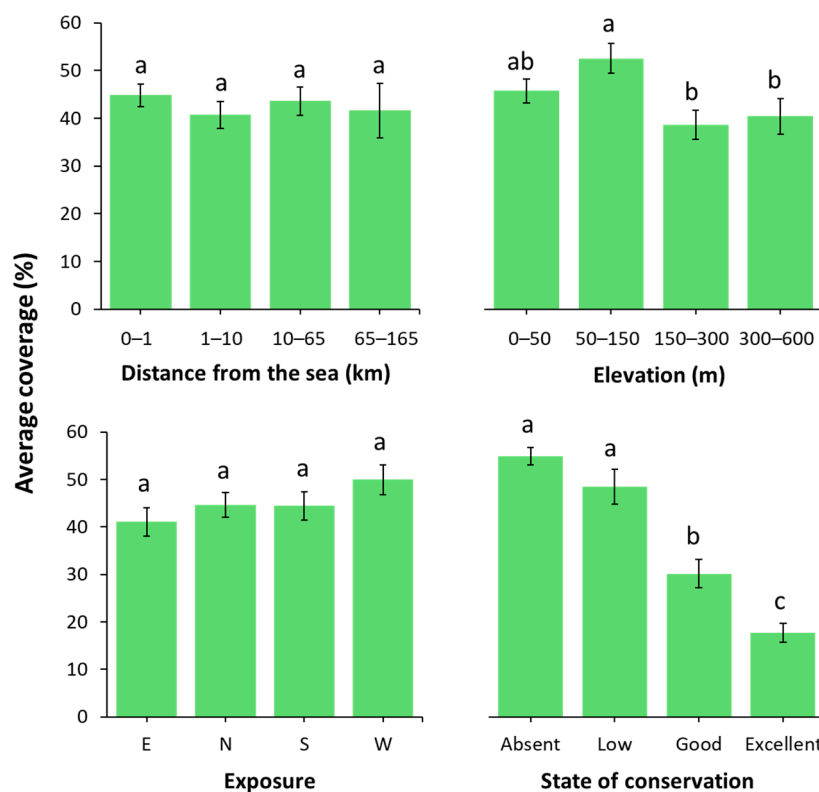
**Figure 4.** Vegetation coverage across the different variables considered. Error bars represent the standard error of the mean (SEM). Bars sharing the same letter are not significantly different according to the Tukey test ( $p < 0.05$ ).

Figure 4 presents the analysis of average vegetation cover across the considered variables. The continuous variables were grouped into four ranges: distance from the sea (0–1, 1–10, 10–65, and 65–165 km) and elevation (0–50, 50–150, 150–300, and 300–600 m a.s.l.). Additionally, four exposition categories and four levels of conservation status were considered: absent, low, good, and excellent.

Distance from the sea and exposure do not show statistically significant differences, suggesting that these environmental factors are not primary drivers of vegetation cover ( $F(3, 386) = 0.416$ ,  $p = 0.742$ ; and  $F(3, 440) = 1.551$ ,  $p = 0.201$ , respectively). In contrast, elevation and conservation status show significant differences among subgroups ( $F(3, 402) = 4.259$ ,  $p = 0.006$ ; and  $F(3, 448) = 37.261$ ,  $p < 0.001$ , respectively). In Figure 5 there is the analysis of life form distribution across elevation and state of conservation ranges. For the elevation, phanerophytes, chamaephytes, and therophytes together account for 45% and 48% of total cover in the first two ranges, whereas their combined cover drops to 32% in the higher ranges.

Regarding conservation status, sites with better maintenance practices exhibit lower levels of colonizing vegetation, as reflected in the cover percentage values. Notably, phanerophytes are more abundant in sites with absent or poor maintenance, whereas hemicryptophytes, typically small and with limited spatial spread, tend to increase progressively along the conservation gradient.

To further explore the factors driving the observed patterns, vegetation response was subsequently analysed in relation to the four variables selected for this study (Figure 4).

Average vegetation coverage was first assessed across elevation, distance from the sea, exposure, and conservation status, revealing statistically significant differences only for elevation and conservation status. Consequently, a more detailed analysis of life form distribution was carried out for these two variables (Figure 5). Life forms, as expressions of plant adaptation to environmental conditions, are key descriptors of climatic regimes, human disturbance, and, in the context of monument colonization, potential hazard levels [27]. In

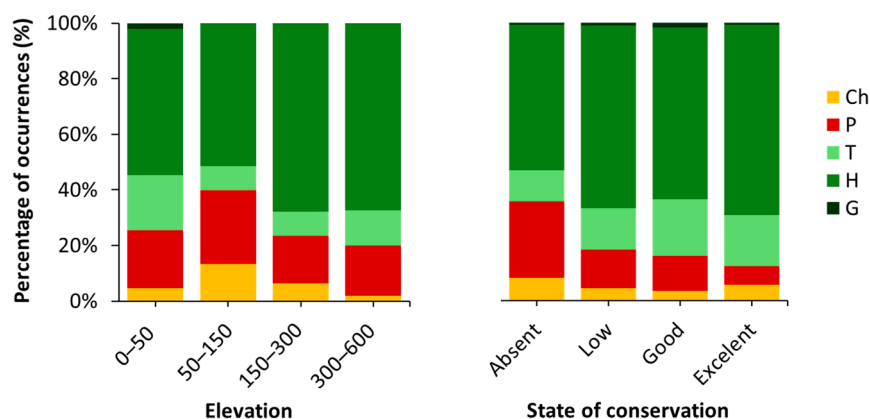
**Figure 5.** Percentage of species occurrences categorized by life forms across elevation and state of conservation (Ch = Chamaephytes; P = Phanerophytes; T = Therophytes; H = Hemicryptophytes; G = Geophytes).

Floristic diversity was also influenced by environmental and structural conditions, including elevation, distance from the sea, and conservation status, as shown in Figure 6. Diversity was assessed using the Shannon Index, which revealed no significant differences in relation to exposure ( $F(3, 440) = 0.164$ ,  $p = 0.92$ ), in contrast to the other variables

The results observed for the elevation can be attributed to the fact that phanerophytes and chamaephytes, typically trees and shrubs, tend to exhibit the highest individual plant cover among life forms. Moreover, they are among the most damaging due to their relatively deep, strong, and perennial root systems, which exert a pronounced mechanical and chemical impact on the stone substrates of walls [4]. This effect is significantly greater when compared to the root systems of other biological types [52,53]. Then therophytes, though generally smaller, can still achieve moderate spatial coverage. Therefore, the predominance of these life forms in the lower elevation ranges results in higher overall vegetation cover. Furthermore, the heterogeneous distribution of life forms contributes to the statistically significant differences observed among elevation ranges. Regarding the state of conservation, an increase in therophytes may be attributed not only to their adaptation to specific edaphic and climatic conditions, but also to the maintenance activities carried out at the sites [52].

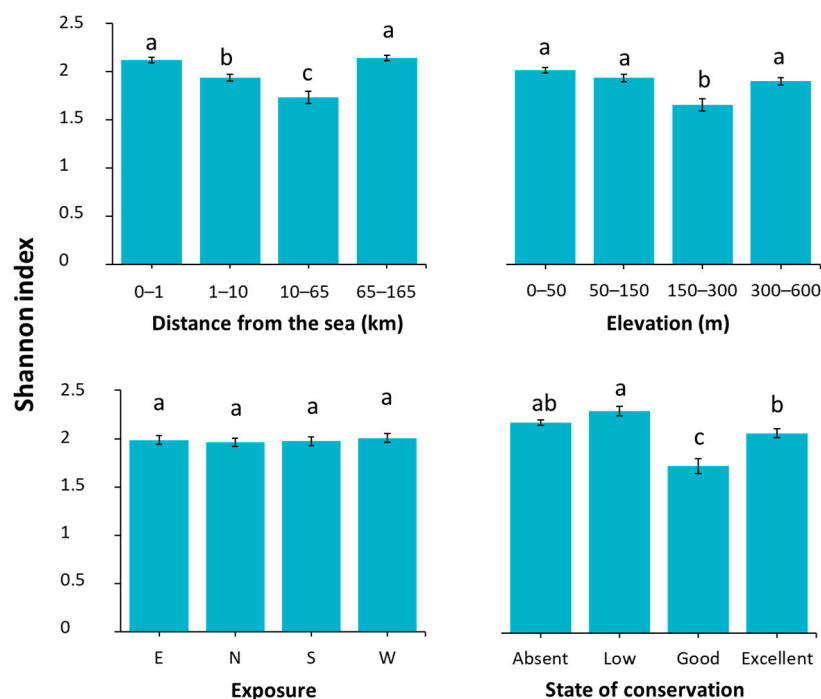
**Figure 6.** Shannon Index across the different variables considered. Error bars represent the standard error of the mean (SEM). Bars sharing the same letter are not significantly different according to the Tukey test ( $p < 0.05$ ).

A significant reduction in the Shannon Index was observed at mid-elevations (150–300 m a.s.l.), whereas both lower (0–150 m) and higher elevations (>300 m) supported greater floristic diversity.

Along the coastal–inland gradient, sites located at intermediate distances from the sea (10–65 km) exhibited significantly lower floristic diversity compared to both coastal (0–1 km) and inland sites (65–165 km).

Finally, sites with low or absent conservation showed the highest levels of floristic diversity, while more well-maintained structures exhibited a significant reduction in diversity.

Beyond species composition and coverage, diversity patterns were investigated using the Shannon index in relation to the selected variables, revealing no statistically significant variation with respect to exposure (Figure 6). Generally, elevational gradients in species richness can follow different patterns, such as a monotonic decline with increasing elevation or a hump-shaped distribution. These trends are typically driven by a combination of climatic conditions, spatial constraints, evolutionary history, and biotic interactions. However, well-defined patterns are less common along short elevational gradients, as in the present study [54,55]. Nevertheless, the reduction of this index at mid-elevations (150–300 m a.s.l.) possibly reflects suboptimal microclimatic conditions for some species in this range. In contrast, both lower (0–150 m) and higher elevations (>300 m) supported greater floristic diversity, likely due to more stable or favourable environmental conditions.

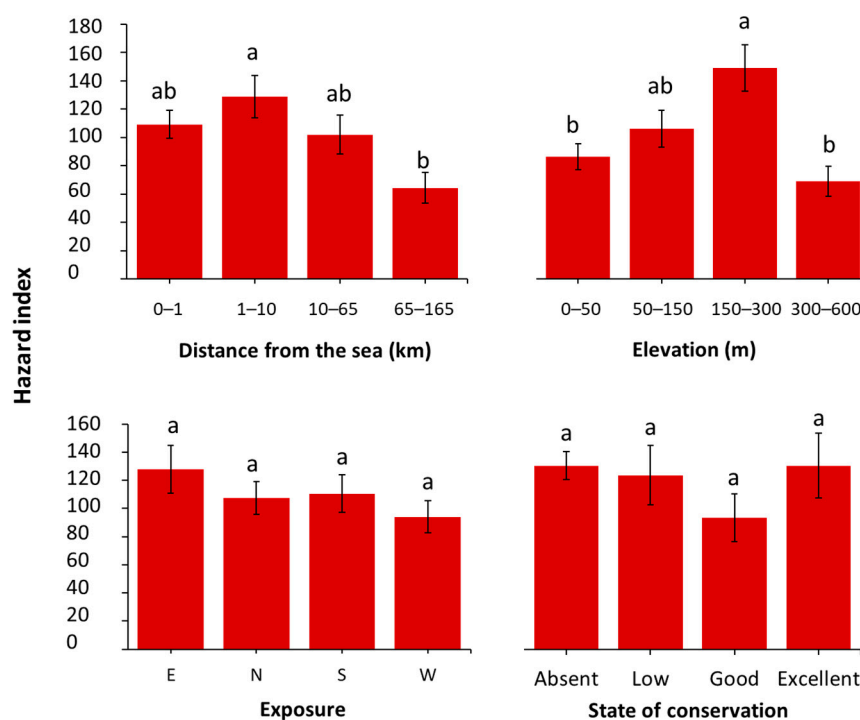
**Figure 7.** The average Hazard Index (HI) across the different variables considered. Error bars represent the standard error of the mean (SEM). Bars sharing the same letter are not significantly different according to the Tukey test ( $p < 0.05$ ).

Across the first three distance bands there are high values of HI, in contrast, the farthest range (65–165 km) recorded the lowest HI values. As for elevation, the highest HI values were observed in the 150–300 m a.s.l. range, while in the remaining elevation bands, particularly in the highest one (300–600 m a.s.l.), there is a decreasing of HI values.

As a final step, the potential impact of deteriogenic flora at the study sites was evaluated using the Hazard Index (Figure 7). Statistically significant differences emerged only across elevation and distance ranges, whereas exposure and conservation status showed no significant effects. These findings can be further interpreted by examining the conservation condition of the sites within each distance and elevation range.

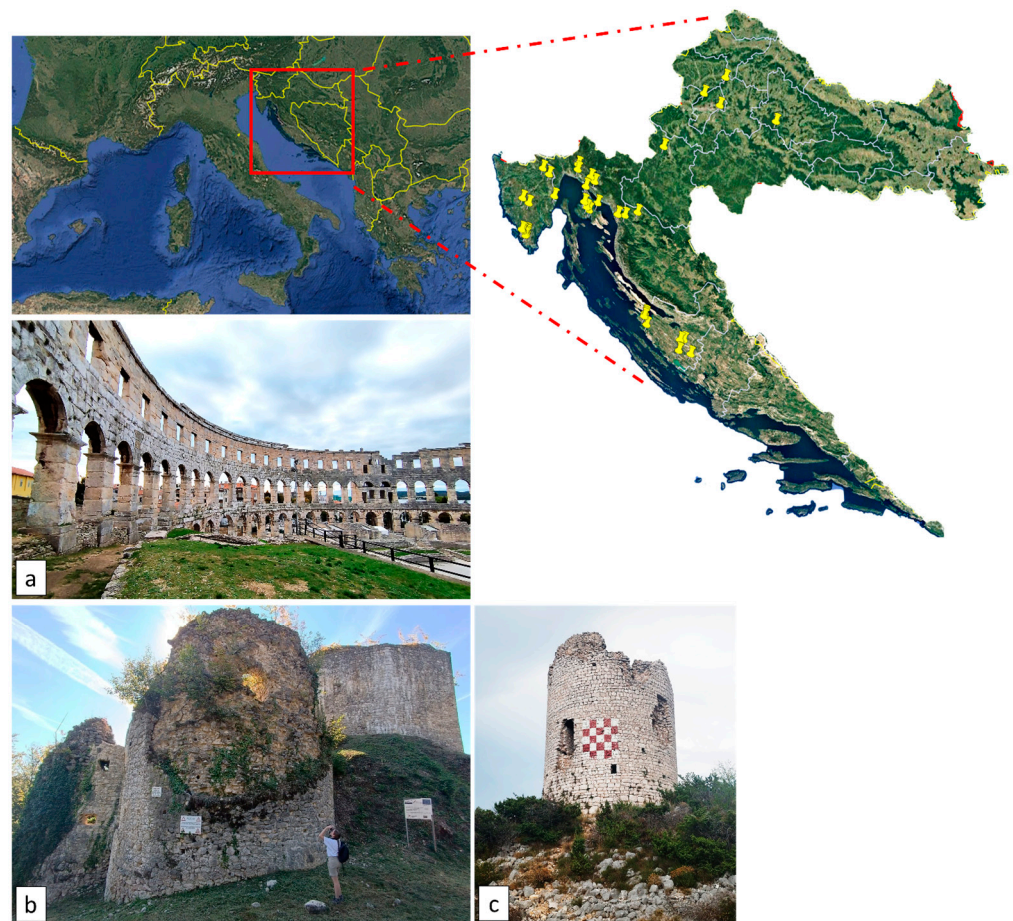
**Figure 8.** Some of the study sites: (a) Amphitheatre of Pula (Istria); (b) Zelingrad castle (Kladešćica, inland); (c) Budak tower (Dalmatia). The yellow points on the map above represent the surveyed study sites (Photo: authors Alessia Cozzolino and Ivana Vitasović-Kosić, 2024).
